Belzona Rebuilds Shaft on Blanching Machine

Bearing seat area of blanching machine shaft.

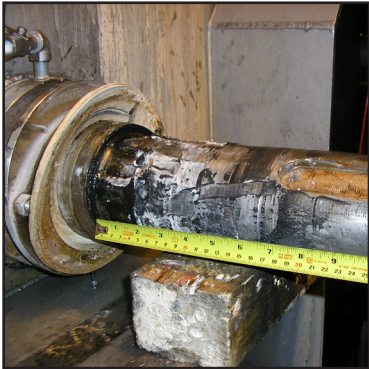
View of worn bearing seat area on shaft

Shaft was worn in the bearing area. This increased pressure on the bearings resulting in a very short service life.

Previously this shaft had been welded up in position and the bearing seat area rough ground back to size. The shaft cannot be taken out without major strip down so an in-situ repair has to be done. The Belzona forming technique produced the precise required diameter.

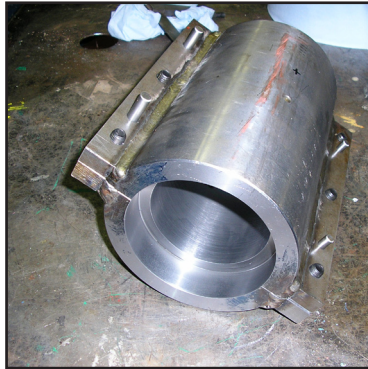
View of former. A stepped former was required to allow it to clamp and locate undamaged areas.

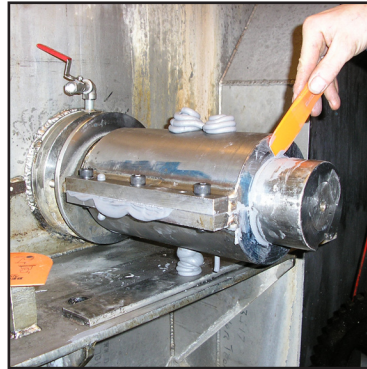
Former after clamping in position

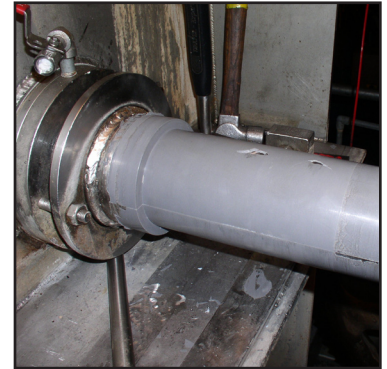
Completed shaft rebuild using Belzona® 1111. Note the step has been rebuilt as well.
