## Belzona Repair Worn Caterpillar Bulldozer Arms

Caterpillar Bulldozer bucket arms

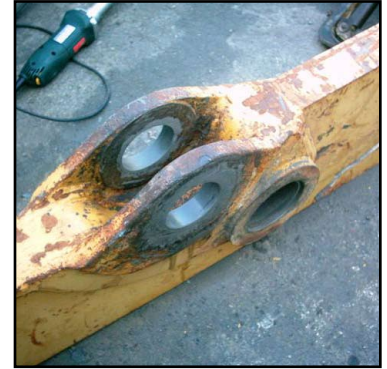
Finished repair

Belzona® 1111  
(Super Metal)
