Belzona Saves Animal Feed Manufacturer

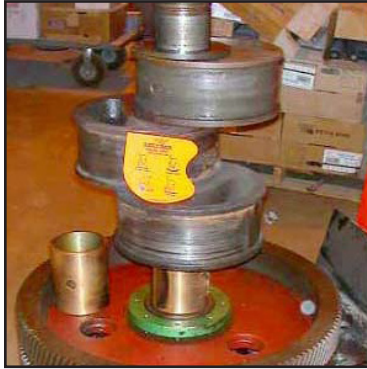
*Crankshaft*

Crankshaft was scored due to debris and low oil levels in the sump.

Application carried out in accordance with Belzona System Leaflet MPT-9. Belzona®1131 was hand applied to the scored journal and subsequently hand finished with fine emery.

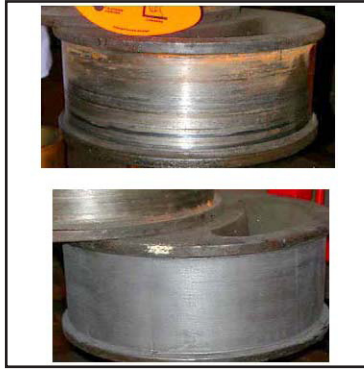
*Close up of scored and repaired bottom journal*

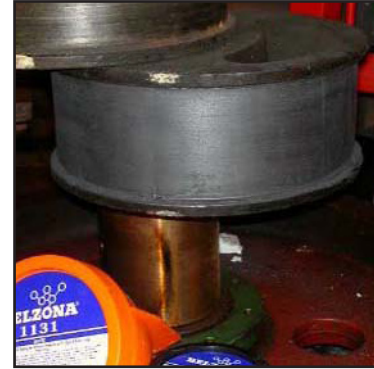
*Another close up of the repair***STATISTICS****CUSTOMER**
