In Situ Shaft Repair With Belzona

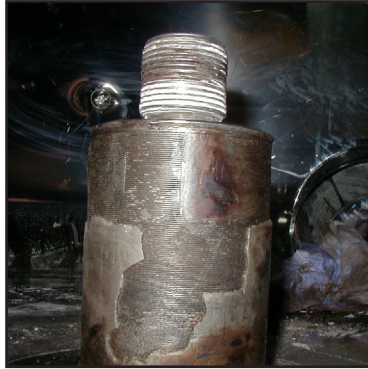
Failed Metal Sprayed Shaft

Customer had un-scheduled failure of mixer vessel drive shaft which had previously been repaired using metal spraying.

Old metal sprayed material was totally removed and shaft rebuilt using Belzona System Leaflet MPT-2. Former was made to allow repair to be completed in-situ.

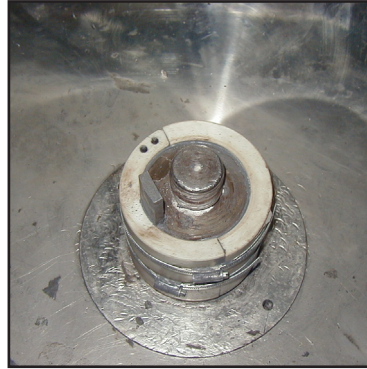
Form tool in position

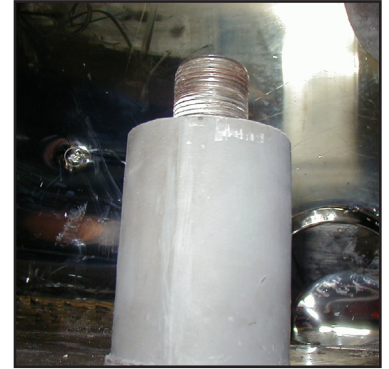
Finished Shaft
