Product Data

Heat Activated Repair Compound for Application to, and Repair of, Hot Surfaces

Belzona® 1251
HA-Metal

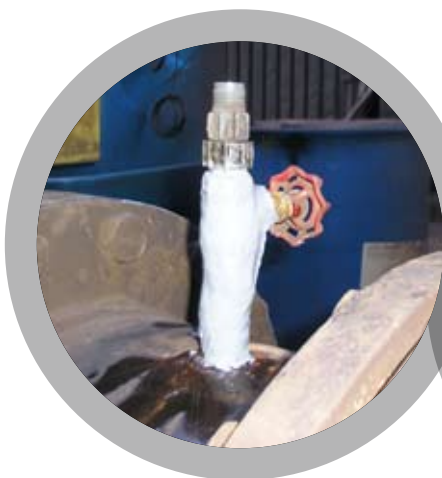
Leak Sealing of Pipework

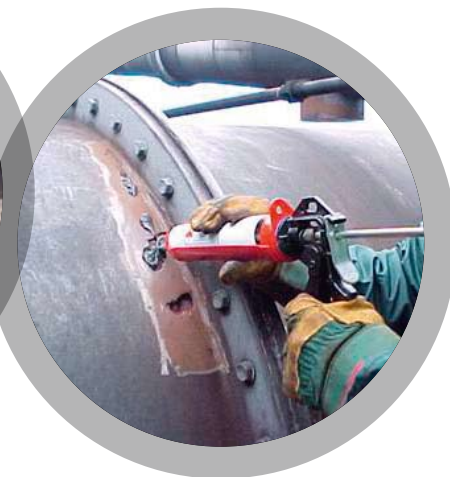
Infill of Corrosion Pits

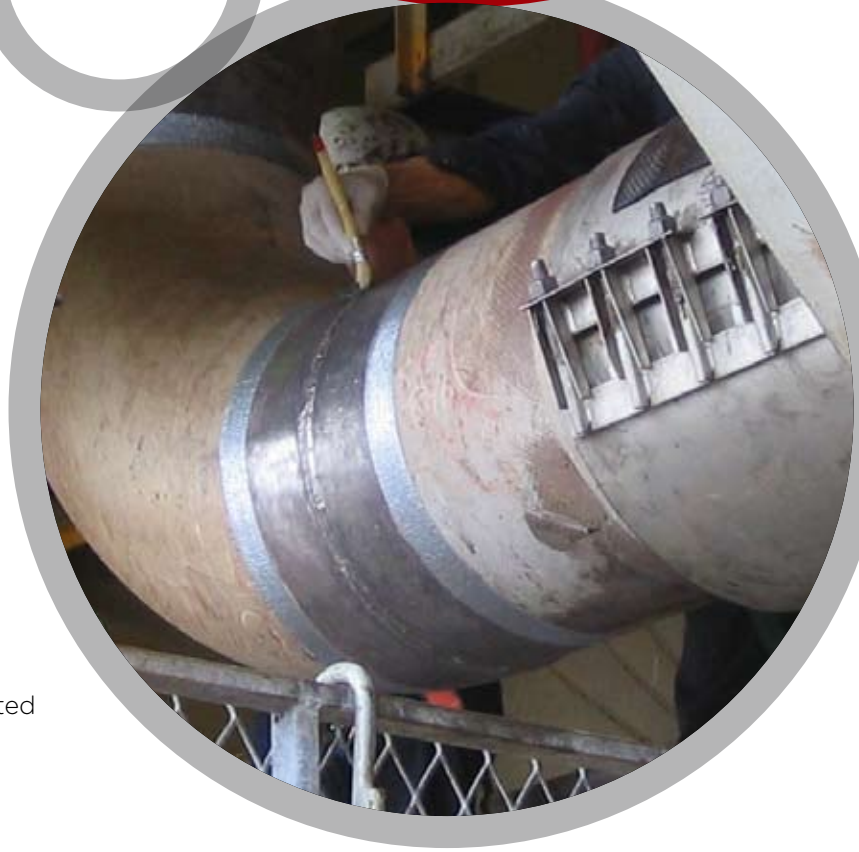
Local Repairs
